COMMONWEALTH OF PENNSYLVANIA  
DEPARTMENT OF ENVIRONMENTAL PROTECTION  
OFFICE OF OIL AND GAS MANAGEMENT

## SURFACE ACTIVITIES INSPECTION REPORT

DEP Office	New Stanton Oil & Gas Office	Inspection Type	PF
Address	131 Broadview Road	Permit or Reg. #	125 - 28566
Addr Cont	New Stanton, PA 15672	ESCGP #	
Oper. Name	RANGE RESOURCES APPALACHIA LLC	Site #	767282
Oper. Address	3000 TOWN CENTER BLVD, CANONSBURG, PA, 15317-5839	Project #	
Resp. Official Name		Farm Name & Well #	GODWIN GEORGE UNIT 15H
Resp. Official Phone		Other Info	
Latitude	40.34289	Longitude	-80.40537
County	Washington	Municipality	Cross Creek Township
Inspection Code	FUI - Follow-up Inspection	Facility	Multi-Well Pad
Permits / Auth	Well Permit	Site Phase	Restored/Prod
Well Info	Unconventional	Well Kind & Description

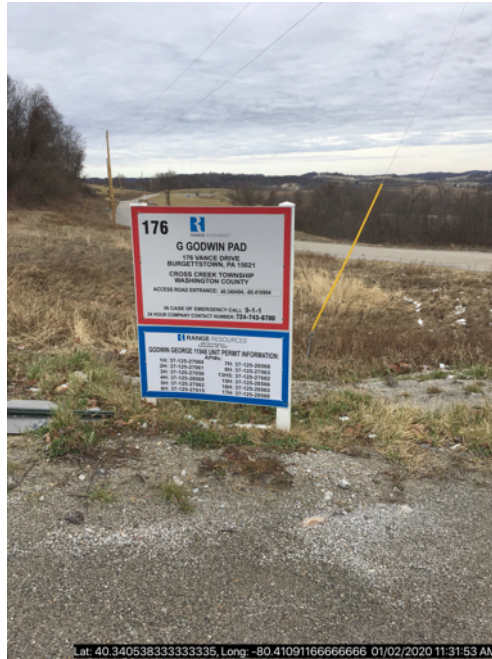
The Act 9 Sign is in place and appears to be in good condition.

Photo #1 Act 9 Sign

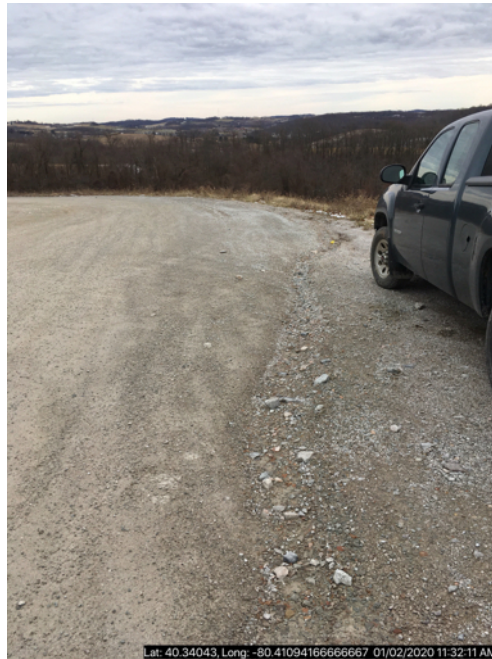
The access road appears to have various accelerated erosion rills along its length from the entrance to the pad. The Department recommends that the operator maintain the access road to prevent further accelerated erosion and sedimentation from occurring.

Photo #2 Accelerated erosion channel at access road entrance

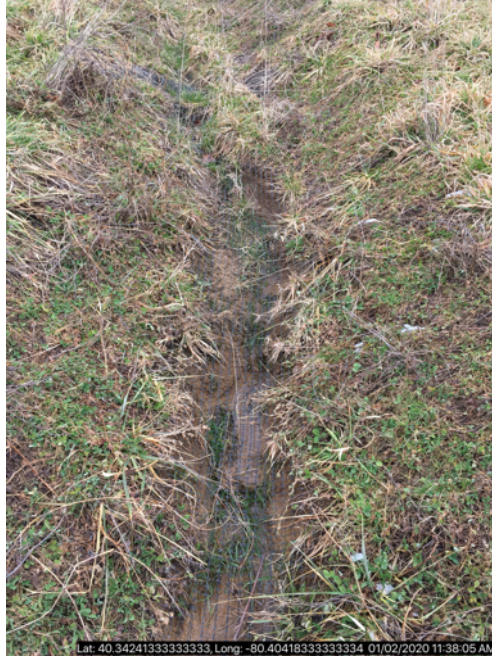
The interceptor channel 2 running to forebay 1 appears to have accelerated erosion channels. The Department recommends that the operator maintain PCSM features to prevent additional accelerated erosion from occurring.

Photo #3 Accelerated erosion channel in interceptor channel 2

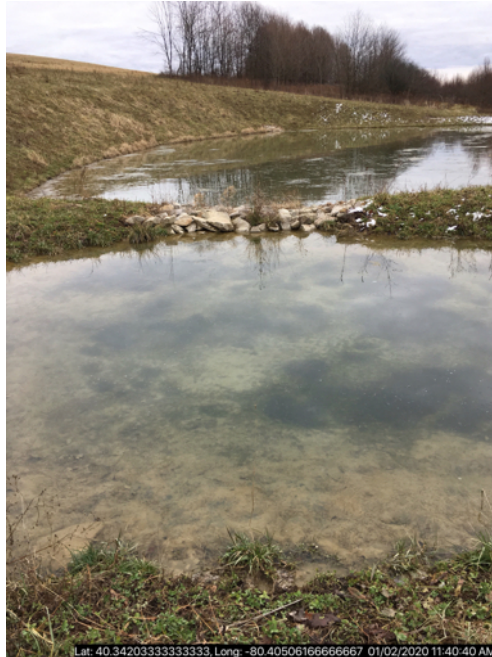
The forebay appears to be filling with sediment, which may be negatively impacting the operation of wet pond 1. The Department recommends the forebay be maintained to prevent an excessive amount of sediment from accumulating.

Photo #4 forebay to wet pond 1

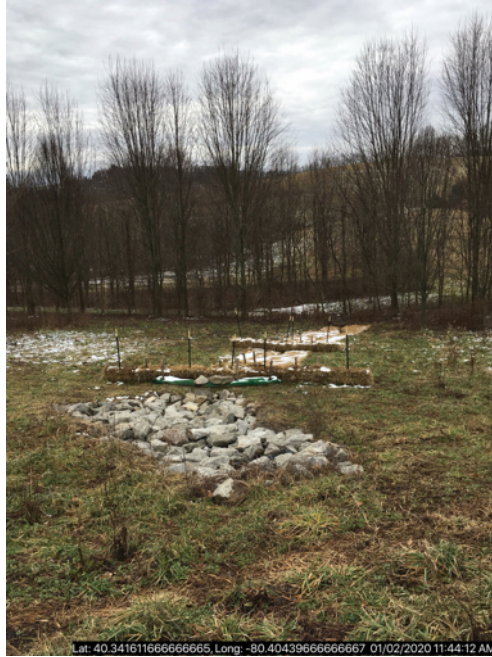
It appears that the operator has put up some straw bale barriers at the discharge point associated with the riprap apron below wet pond 1 (mentioned in inspection 2959521) along with an erosion control blanket along the erosion channel to the edge of the LOD of previous accelerated erosion. Based on the Department's observation, accelerated erosion appears to still be occurring as water pools around the straw bales. Per the E&S Manual's Standard Construction Detail # 4-13 it does not appear that this corrective measure was constructed properly. Additionally, according to the E&S Manual on page 233, riprap aprons should be constructed at or near zero grade. It appears that this riprap apron is slanted to one side which is causing water to pool, and thus creating the accelerated erosion that is being observed at the site. The Department recommends that the operator maintain these features to prevent continued accelerated erosion.

Photo #5 Riprap Apron incident site

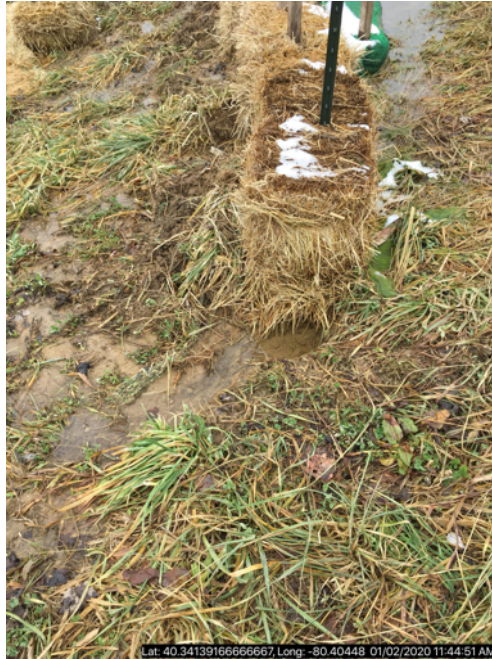
Photo #6 Repair area

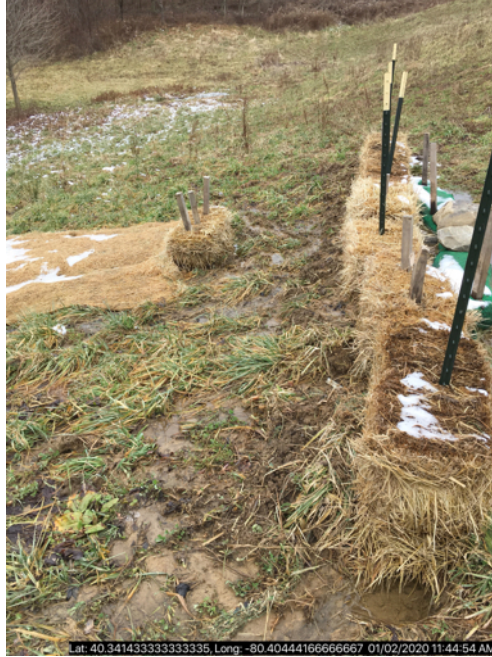
Photo #7 Straw bale barrier

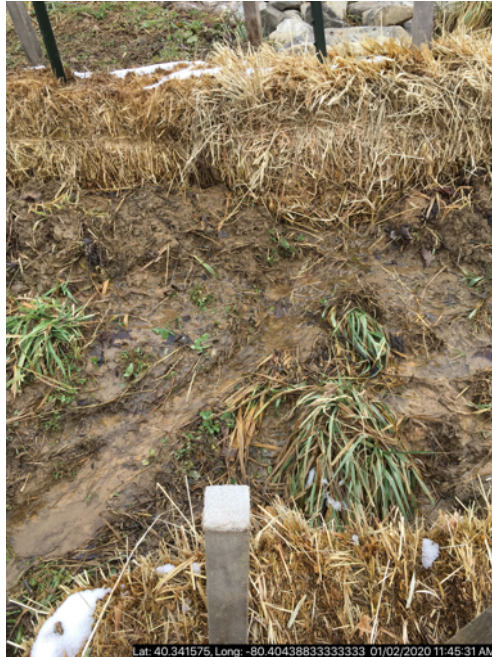
Photo #8 Below first set of straw bale barriers

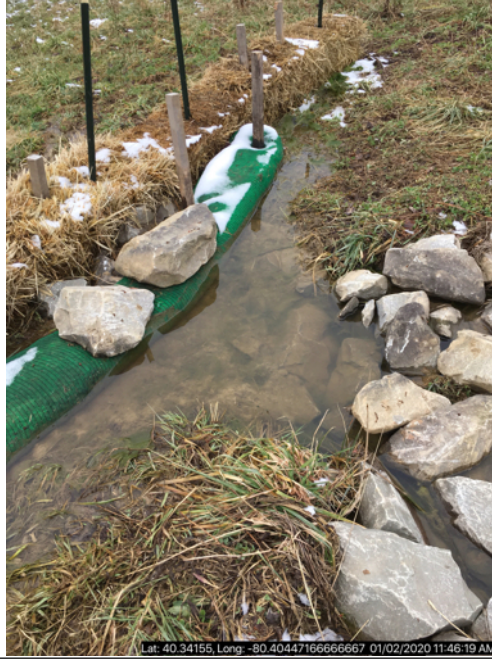
Photo #9 Riprap apron to straw bale barrier

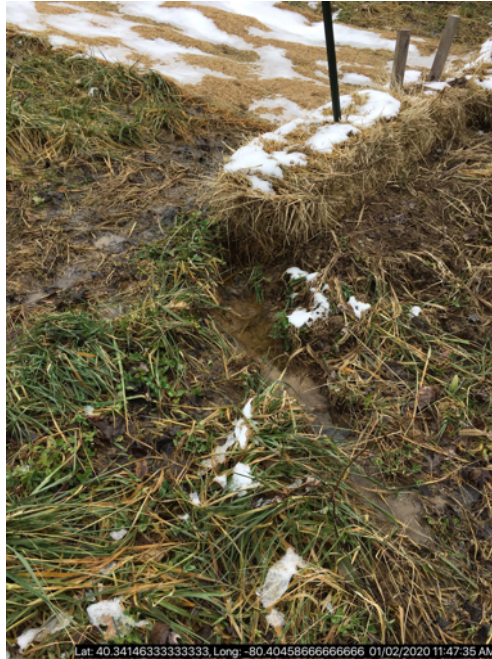
Photo #10 straw bale barrier with accelerated erosion

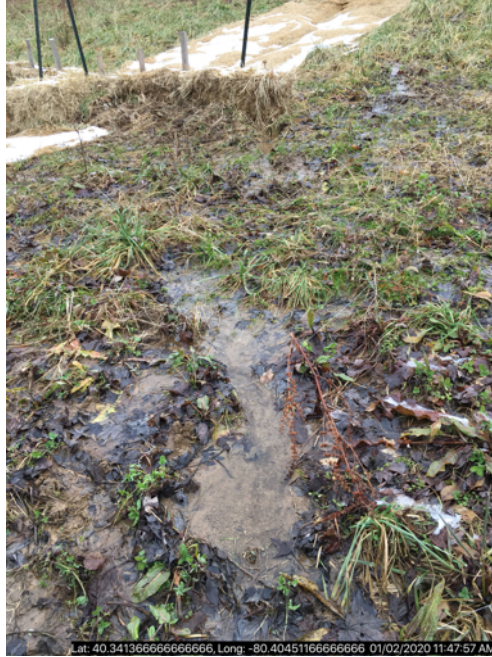
Photo #12 accelerated erosion

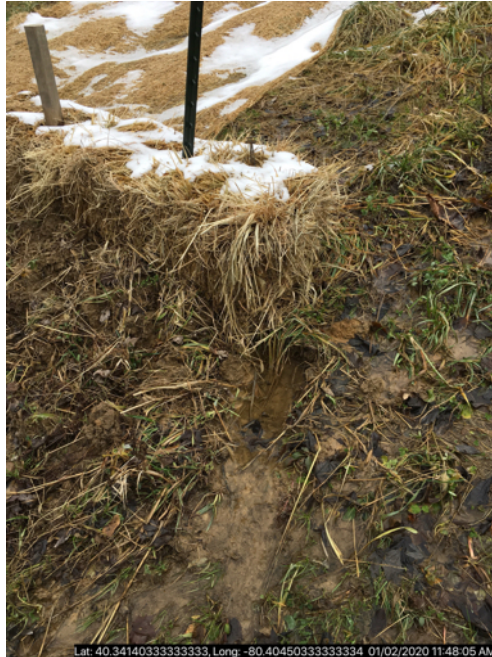
Photo #13 accelerated erosion

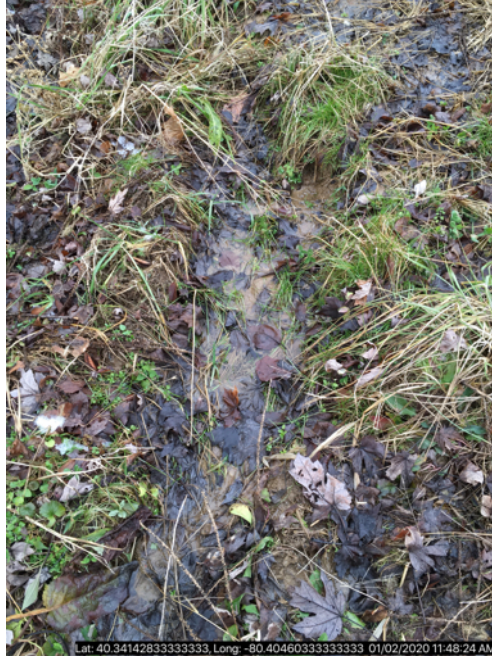
Photo #14 Accelerated erosion channel

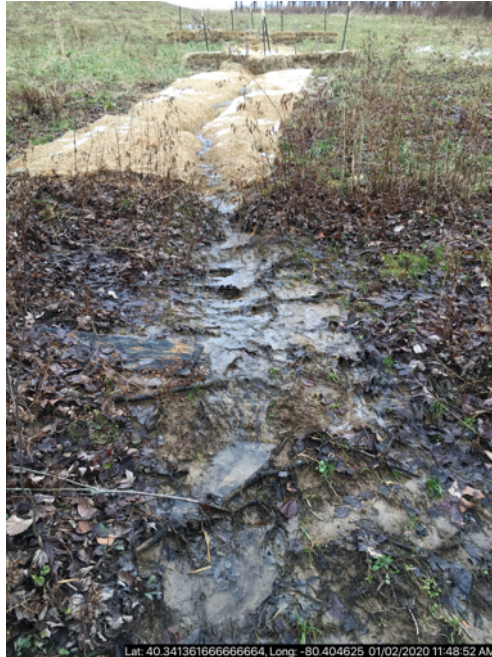
Photo #15 Off LOD

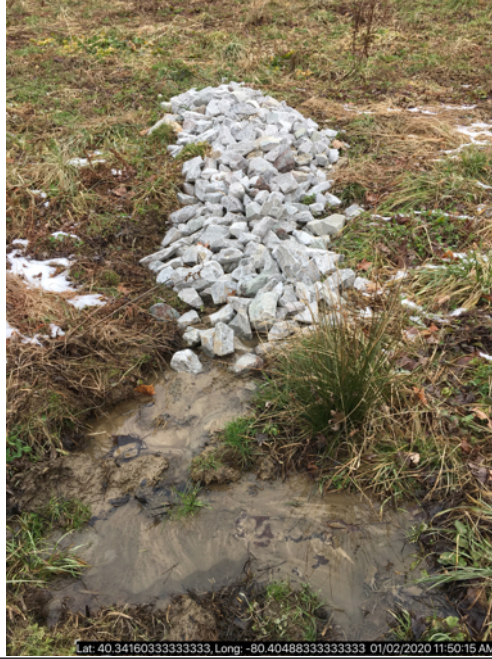
The outlet pipe for the under drain mentioned as part of inspection 2959521 has what appears to be riprap dumped over top of it and is still continuously discharging water which appears to be continuing to erode a channel through the field. The Department recommends that the operator maintain this feature to prevent continued accelerated erosion from occurring.

Photo #16 Riprap over top outlet drain

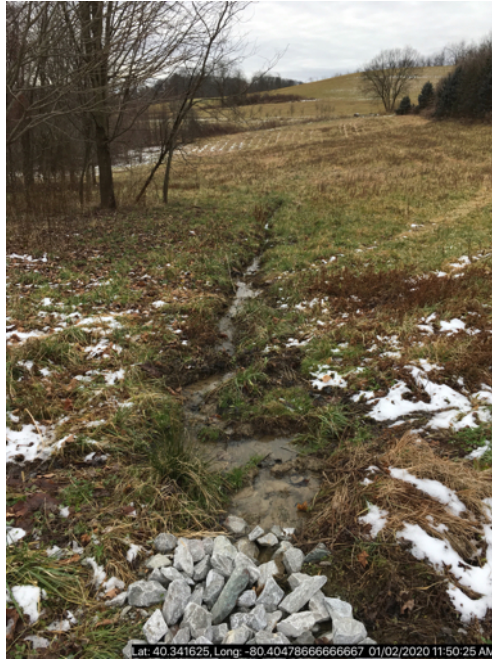
Photo #17 Accelerated channel from outlet drain
