DEP Office	Eastern Oil & Gas District Office	Inspection Type	PF
Address	208 West Third Street, Suite 101	Permit or Reg. #	081-21946
Addr Cont	Williamsport, PA 17701-6448	ESCGP #	----
Oper. Name	EQT ARO LLC	Site #	846726
Oper. Address	400 WOODCLIFF DR CANONSBURG, PA 15317-5851	Project #	MALLORY PAD A
Resp. Official Name	Rick Hall	Farm Name & Well #	Mallory Pad A
Resp. Official Phone		Other Info	----
Latitude	41.45893	Longitude	-76.82136
County	Lycoming	Municipality	Plunketts Creek Township
Inspection Code	FUI - Follow-up Inspection	Facility	Multi-Well Pad
Permits/Auths	Well Permit	Site Phase	Drill/Alt
Well Info	Unconventional	Well Kind & Description	Horizontal Well

**SURFACE INSPECTION REPORT**

Inspection Record No. 3759289
Enforcement Record No.

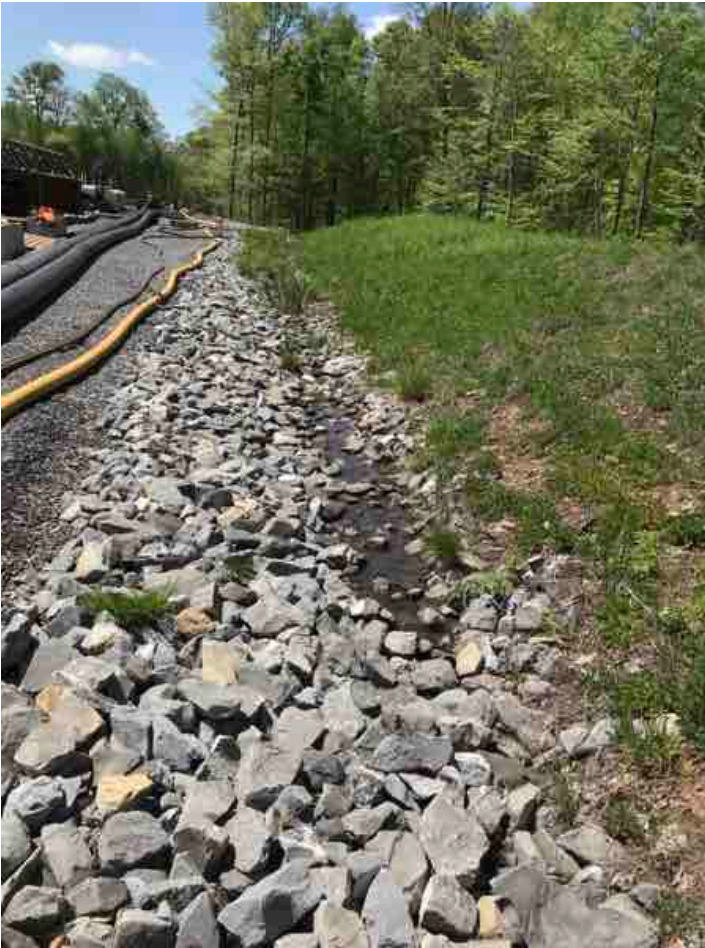
**#: 1**

Fluid is present in the stormwater channel along the northwest pad edge. The fluid is present in the channel from the approximate halfway point of the pad edge to the compost filter sock infiltration berm at the west corner of the pad. The electrical conductivity (EC) of the fluid is 4.46 mS/cm near the halfway point of the pad edge. Approximately 25 feet west within the channel, the EC peaked at 10.23 mS/cm and then gradually decreased as it headed farther west within the channel. The EC of the fluid where the path of the fluid ended at the compost filter sock berm at the west corner is 2.43 mS/cm.

I notified the company man about the elevated EC fluid in the stormwater channel and then took sample 0718-237 from the fluid in the stormwater channel at 1242. The sample was sent to the state laboratory on the same day to be analyzed for SAC 942 plus Br, Li, and Al.

I left a voicemail for EQT representative Rick Hall at 1338 on the same day to let him know of my findings. Later that day at 1555 I spoke with EQT representative Zac Subra. He told me that an internal investigation found that a contractor was flushing lines which had contained produced fluid following fracing operations. The contractor released what they believed to be freshwater which actually contained some portion of produced fluid. Mr. Subra said that they believe that this was the origin of the fluid in the channel and that EQT intends to pursue Act 2 remediation for this release. He also stated that a vacuum truck was already on site removing the fluid with elevated electrical conductivity. He said Penn E&R and Tobias Excavation was en route to the site to characterize and excavate the impacted material, respectively.

The stormwater channel along the northwest side of the well pad looking to the west from the approximate halfway point of the pad edge. The fluid in the channel had an electrical conductivity of between 2.43 mS/cm to 10.23 mS/cm.

The Department recommends pursuing Act 2 remediation due to the unknown volume of the release.

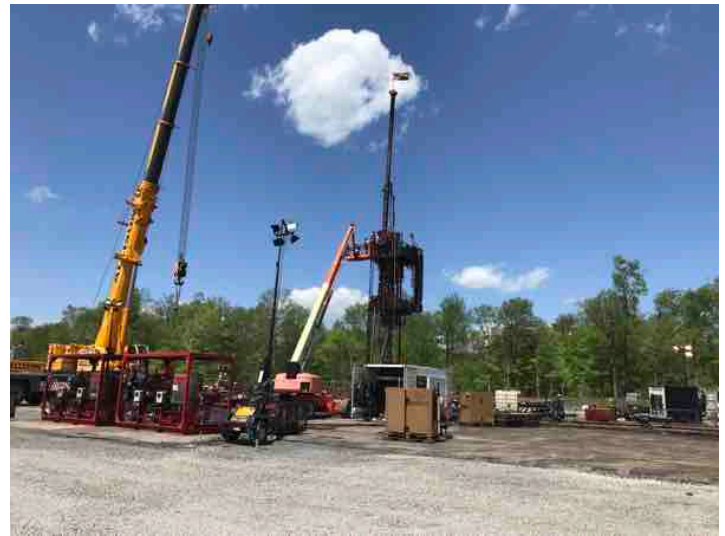
**#: 2**

The workover rig in operation on the well pad.

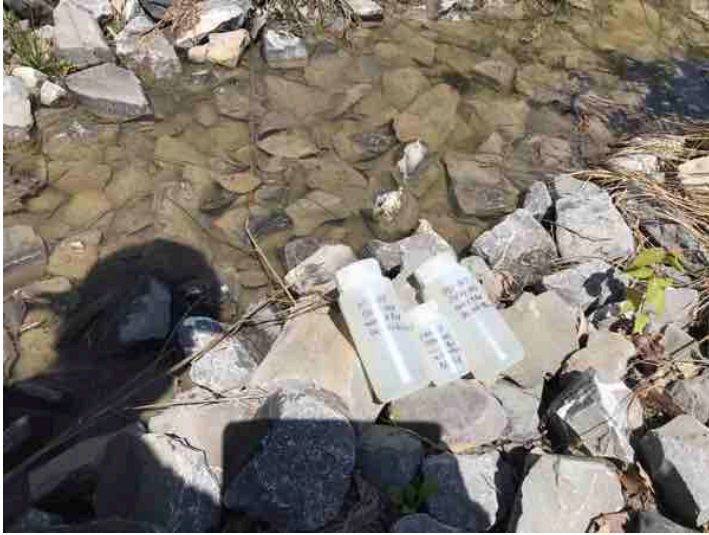
**#: 3**

SAMPLE NO.	LOCATION / DESCRIPTION	DATE OF SAMPLE	TIME
0718-237 DEP Lab	Lat: 41.459194 Long: -76.822029 Location: Mallory Pad A Description: Northwest Stormwater Channel	05/08/2024	12:42 PM

Sample 0718-237 taken from the northwest stormwater channel during this inspection.

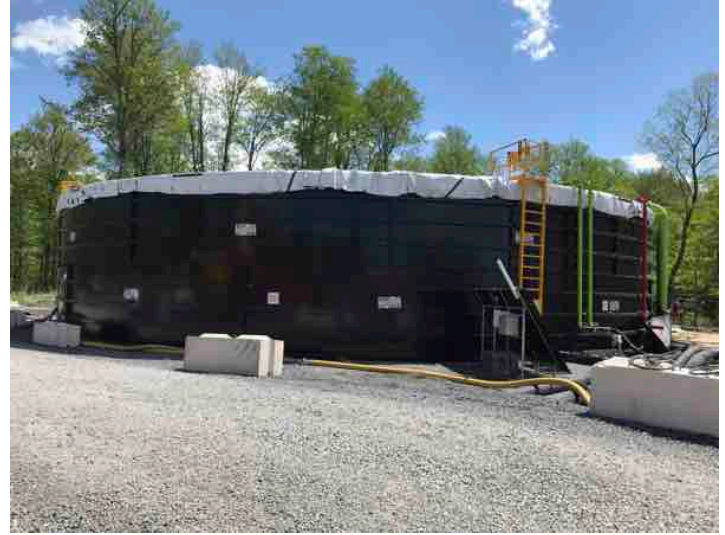
**#: 4**

The MASS present on the well pad.
