SURFACE INSPECTION REPORT

DEP USE ONLY Inspection Record No. 3762896

On 05/15/2024, a routine partial inspection was conducted at the Mingo Well Site. NWE crew onsite.

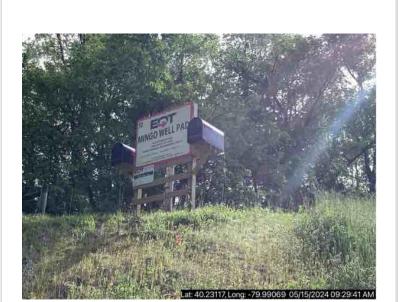
#: 1

Act 9 sign at site entrance. PPC plan and ERP in mailbox (Photo 1). The site has been constructed, however no wells have been drilled.

Act 9 sign

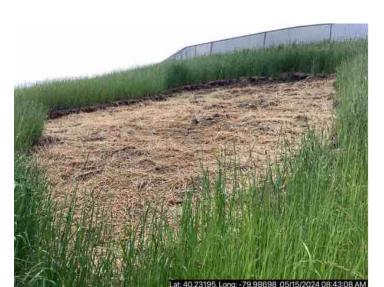
#: 2

A slope failure, discovered by the Department, had occured on the northern fill slope of the pad. The slope failure looked to have had surface sloughing. The failure was approximately 50 feet in length, approximately 15-20 feet in width, and with an escarpment of approximately one foot (Photos 2-5).

Approximately 50 feet in length

The Department requests that a Geotechnical Report be submitted to Technical Services

The Department recommends that the Operator works with Technical Services for any Potential Modification of Permit to address Slope Failure(s)

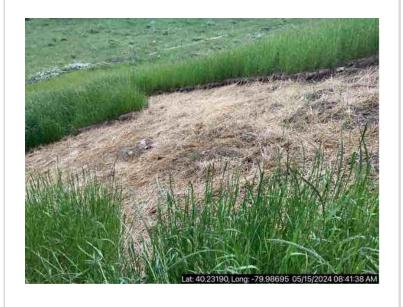
#: 3

Approximately 15-20 feet in width

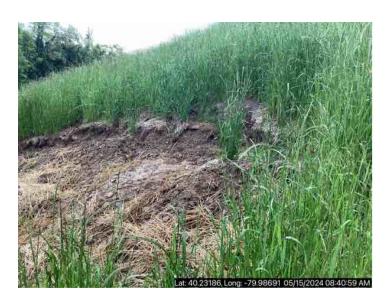
#: 4

Scarp approximately 1 foot

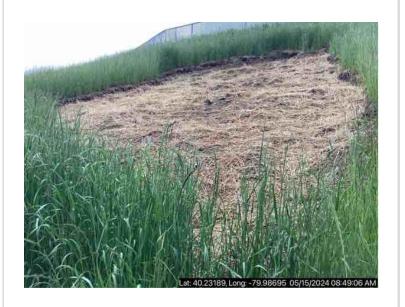
Failure area Toe of failure

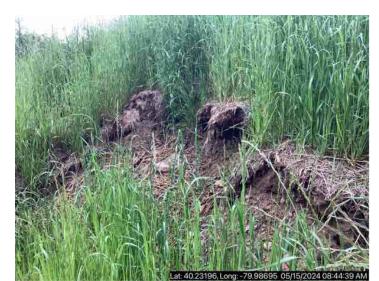
The toe of the failure was displaying an escarpment of approximately 1 foot (Photos 6, 7).

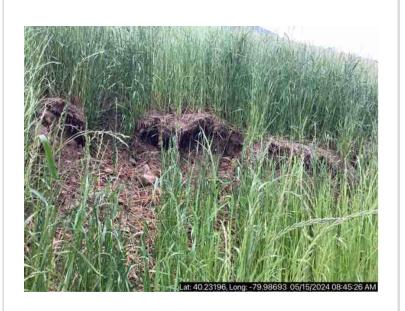
Toe of failure

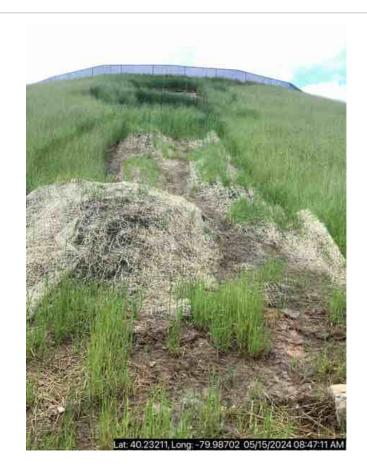
There was additional surface sloughing below the failure area which appeared to be approximately 25 feet in length and approximately 10-15 feet in width (Photos 8, 9).

Lower sloughing

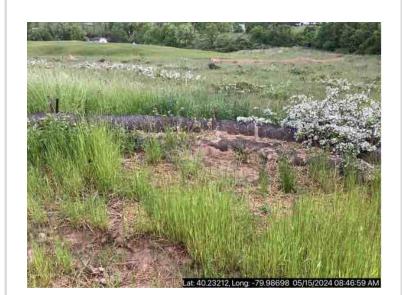
#: 9 #: 10

The filter sock at the base of the slope appeared to require maintenance as sediment has accumulated (Photo 10).

Lower sloughing Sock at base of slope
